Province of British Columbia  
Ministry of Environment  
Water Management Branch

PRELIMINARY REPORT ON  
OYSTER RIVER FLOODING AND EROSION

A. A. Brown, P. Eng.  
Senior Hydraulic Engineer

Victoria, B. C., April 1982

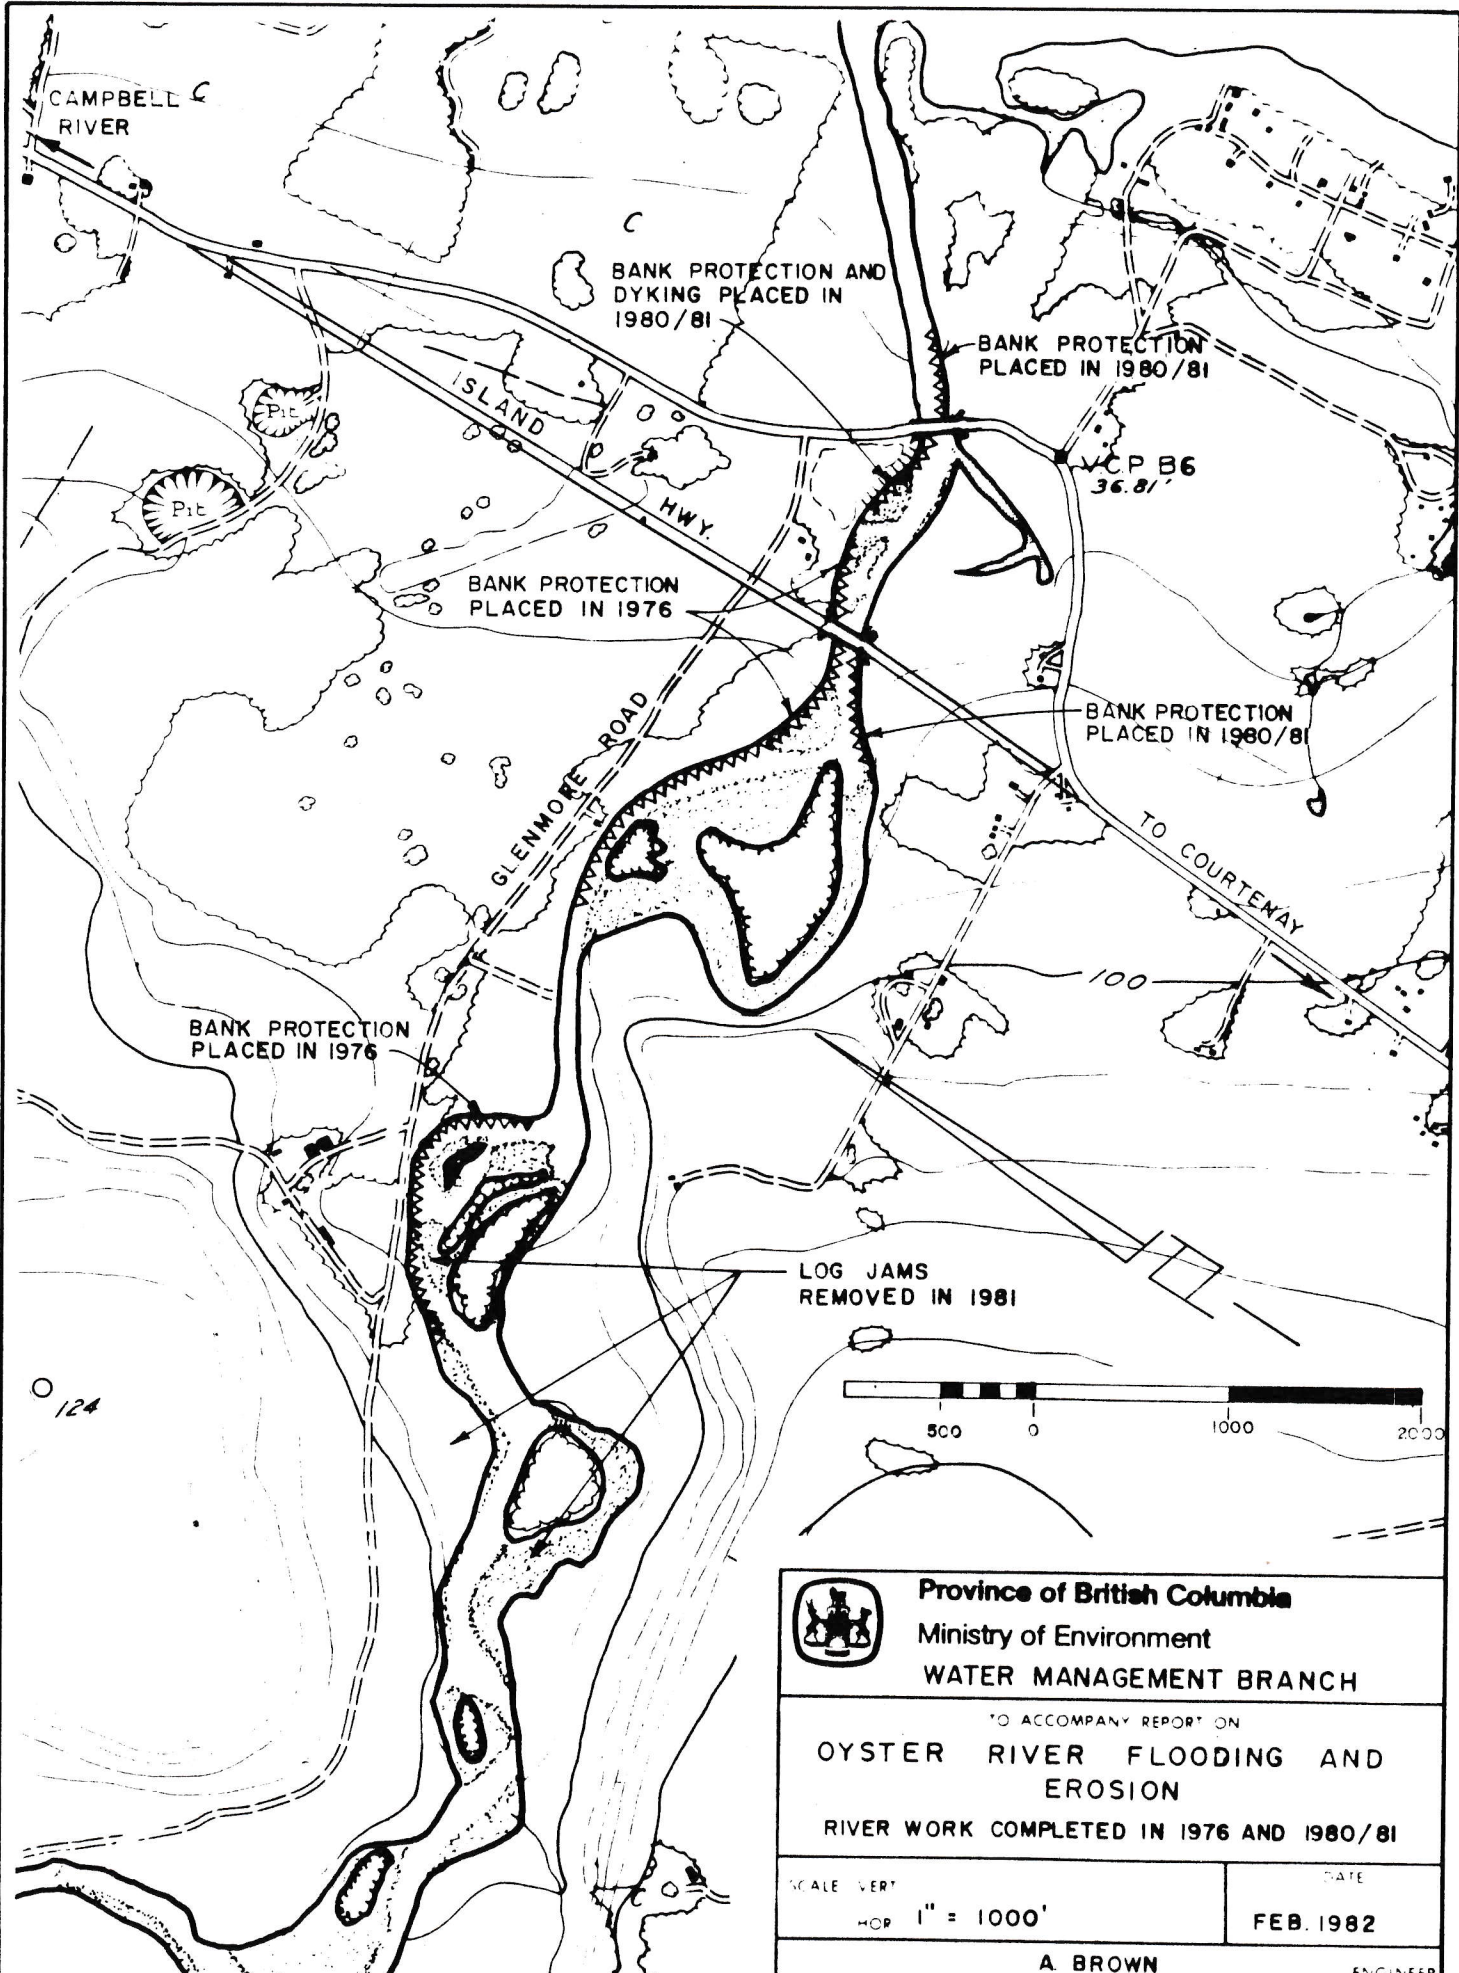
TO ACCOMPANY REPORT ON  
 OYSTER RIVER FLOODING AND EROSION  
 RIVER WORK COMPLETED IN 1976 AND 1980/81

In 1976, following the high flows in November 1975, bank protection was placed in three areas (see Drawing 4918-73-31-13) on a 75%-25% cost sharing basis with the local 25% share being provided through a specified services area created under the Regional District of Comox-Strathcona. A proposal to construct some dyking on upper Glenmore Road was deferred at that time.

In December 1980, high flows occurred again and considerable erosion and flooding damage was done in two areas. Extensive dyking and riprap repair work was undertaken to these two areas, on the left bank between the two highway bridges and on the right bank downstream of the old Island Highway bridge (as shown on Drawing 4918-73-31-13). In addition, minor repairs to the existing rock riprap were made and one large log jam and two smaller ones were removed. All this work was paid for under the Provincial Emergency Program at no cost to the residents. The cost was approximately \$230,000.

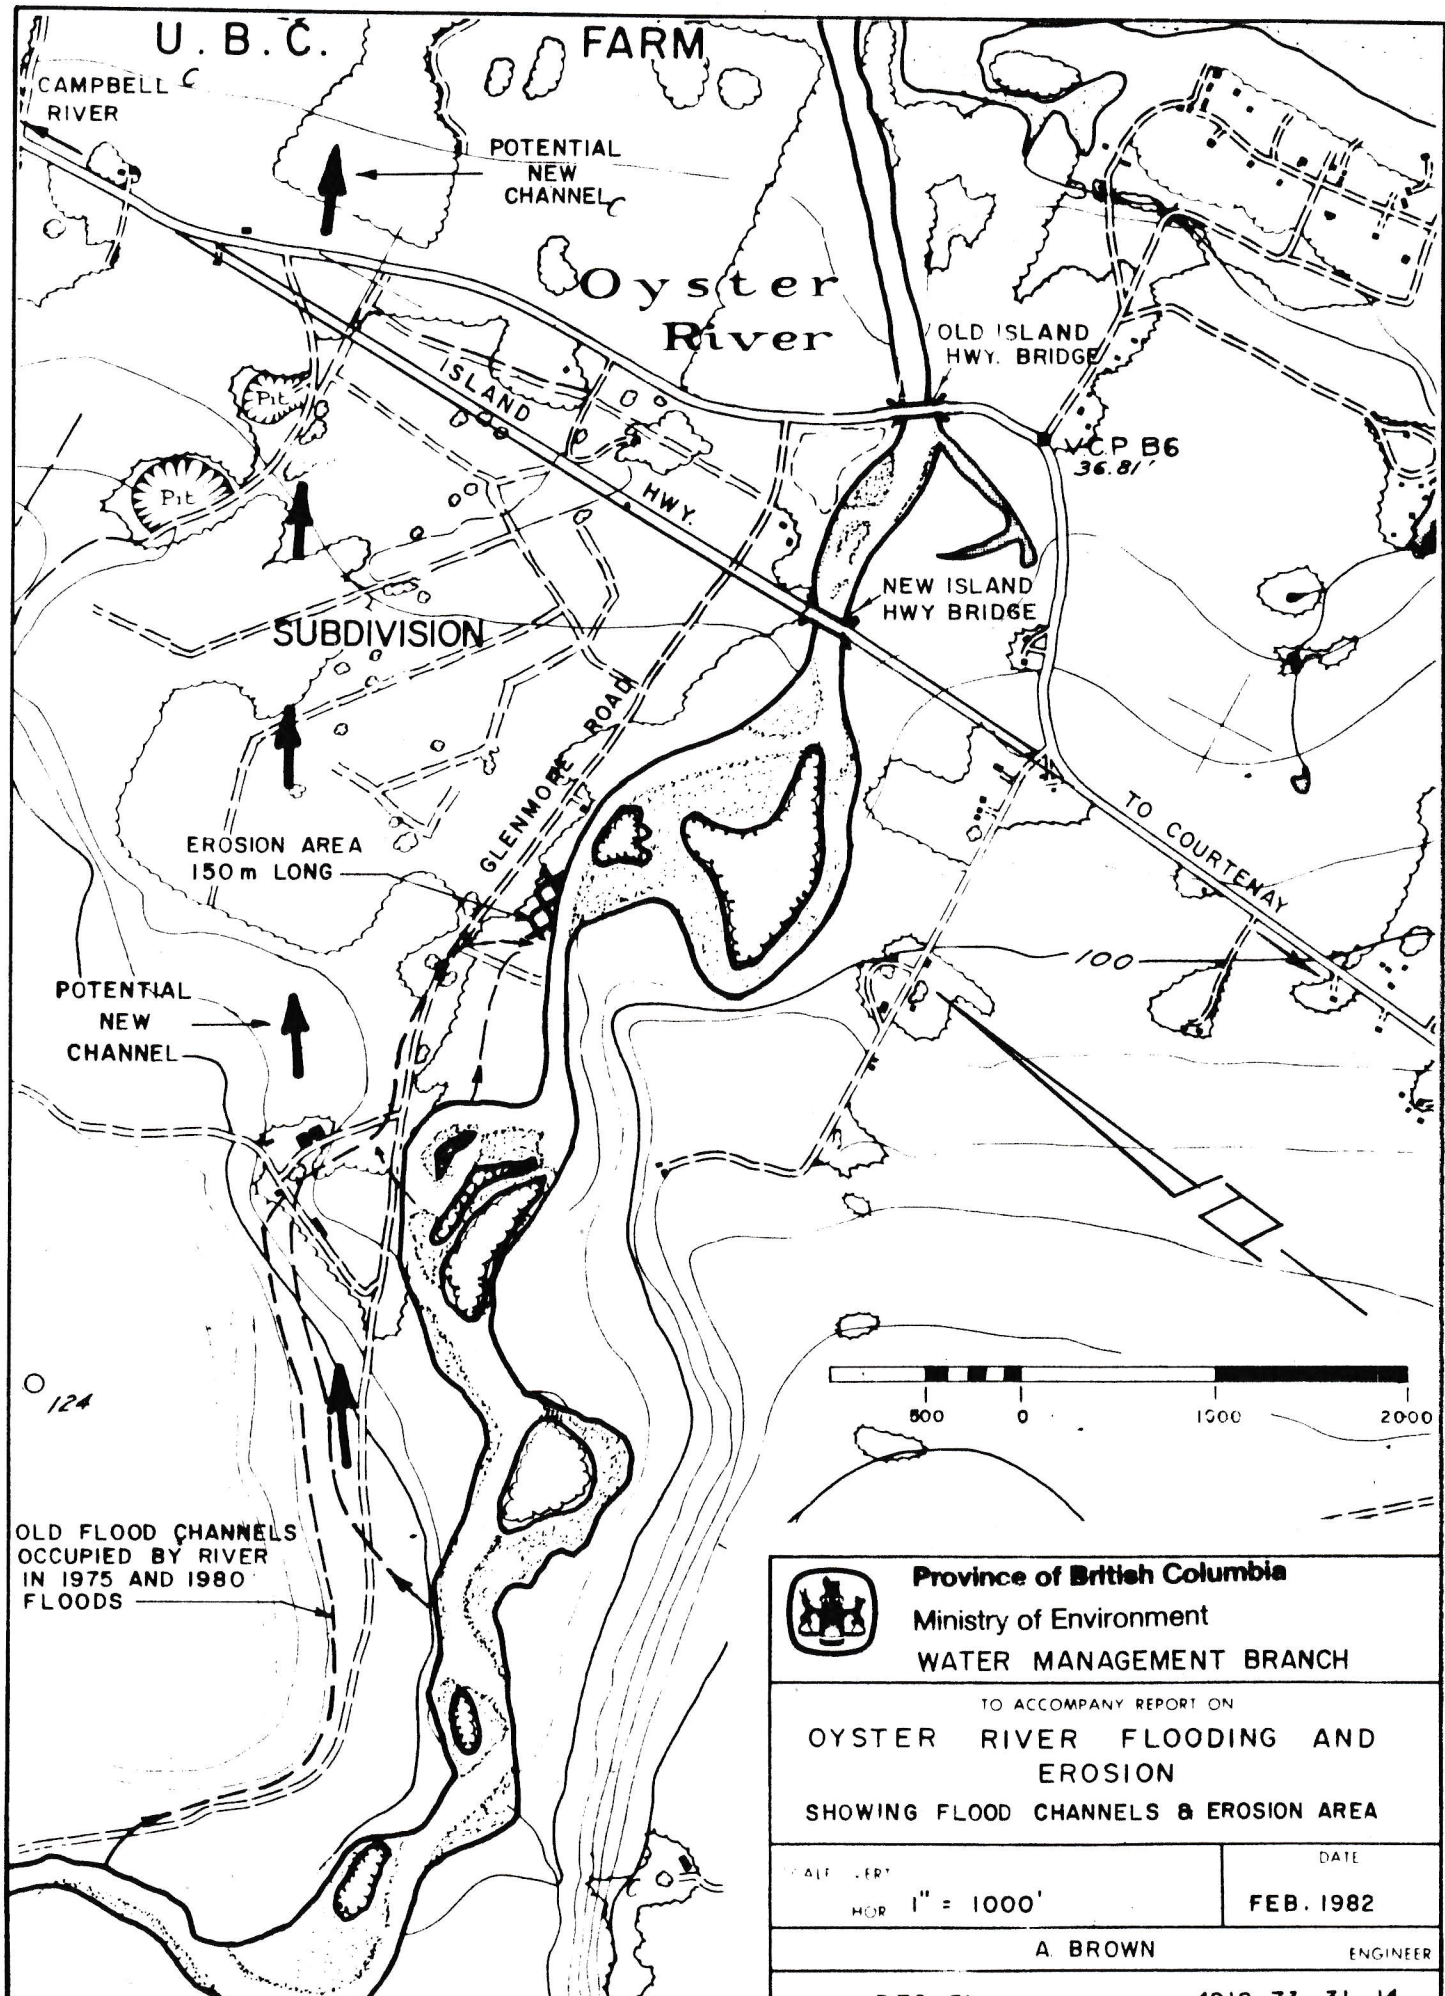
<b>Province of British Columbia</b> Ministry of Environment WATER MANAGEMENT BRANCH	
TO ACCOMPANY REPORT ON <b>OYSTER RIVER FLOODING AND EROSION</b> SHOWING FLOOD CHANNELS & EROSION AREA	
SCALE: VERT HOR 1" = 1000'	DATE <b>FEB. 1982</b>
<b>A. BROWN</b>	ENGINEER

Work under the Provincial Emergency Program was restricted to restoring the river system and existing works as near as possible to the condition which existed prior to the December 26, 1980 flooding. Two problem areas which are illustrated on Drawing 4918-73-31-14 are still outstanding. These problems are as follows:

1. Overbank flow from the old river channels in the upper Glenmore Road area still occurs during high water, flooding eight homes and cutting off traffic along Glenmore Road. In addition, the local residents are quite concerned that the river may, if not checked, jump its banks during high flow and create a new channel through a subdivision and the U.B.C. farm area to the north. A petition containing some 165 names expressing this concern was sent to the Minister on February 20, 1981.

2. Erosion on the left bank of the river just upstream of the end of the rock riprap placed in 1976 has occurred. The erosion area is some 150 metres long and the bank height varies from 6 metres at the lower end to 2.7 metres at the upper end. Requests for assistance have been received from two land-owners who have recently built new homes. No homes are at present threatened and only minor loss of land is occurring at this time, but the upstream end of the riprap placed in 1976 is being threatened.
