*State
of the
Tsolum River*

*A comprehensive report on work completed
by the Tsolum River Task Force*

April 1997 – March 1999

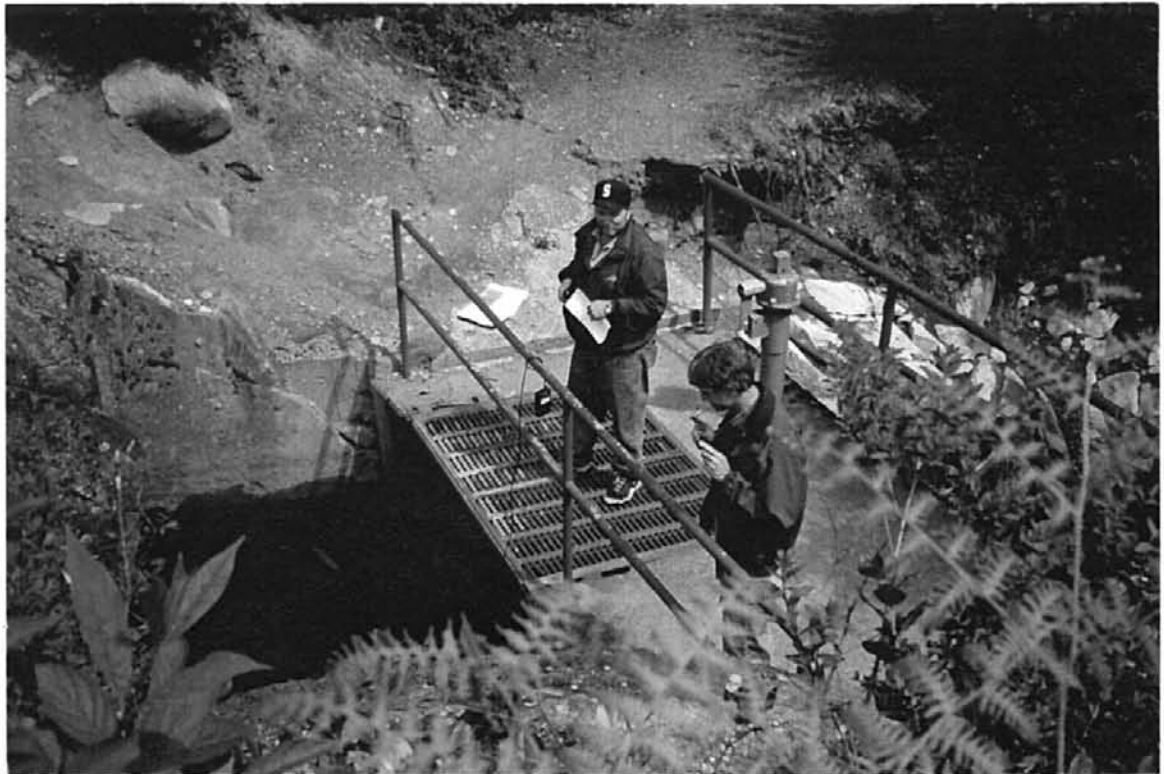
Figure B.2 Wolf Lake Dam, a stream temperature monitoring site (summer 1998).

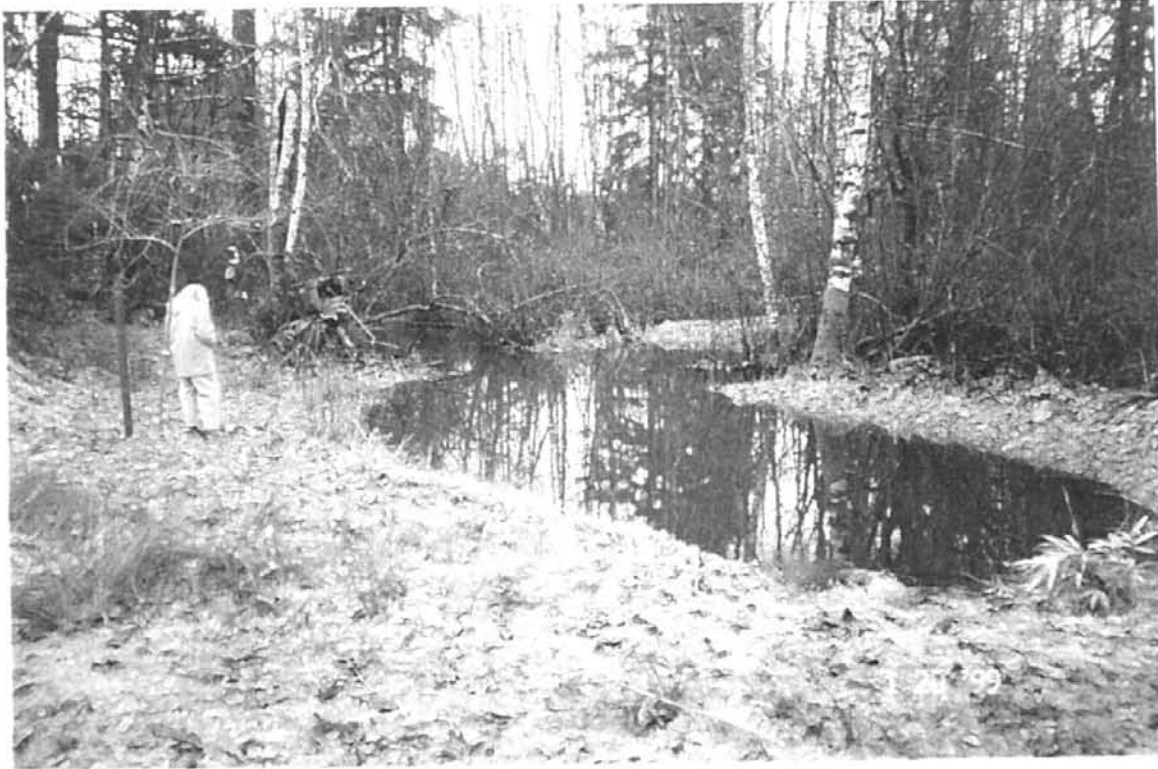
Figure B.1 Near-Stream Refuge Pond, Poulton Road, Merville, B.C.

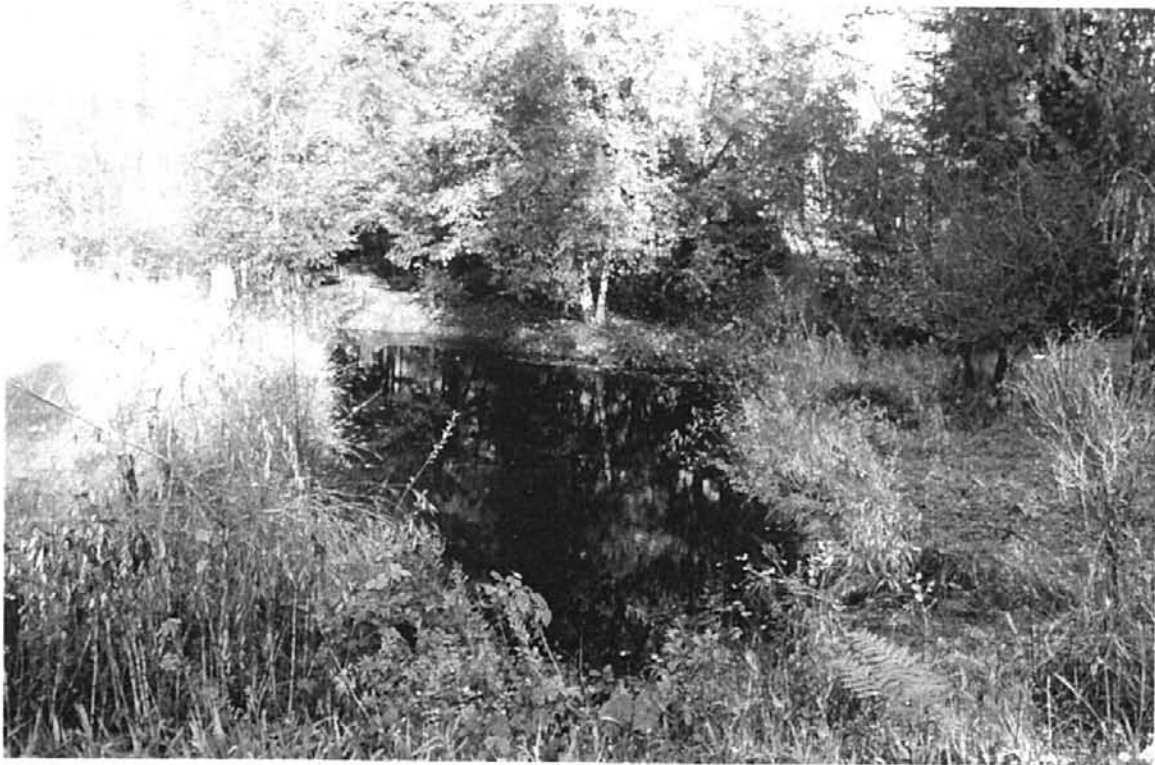
Figure B.2 In-Stream Refuge Pond, Merville Road, Merville, B.C.

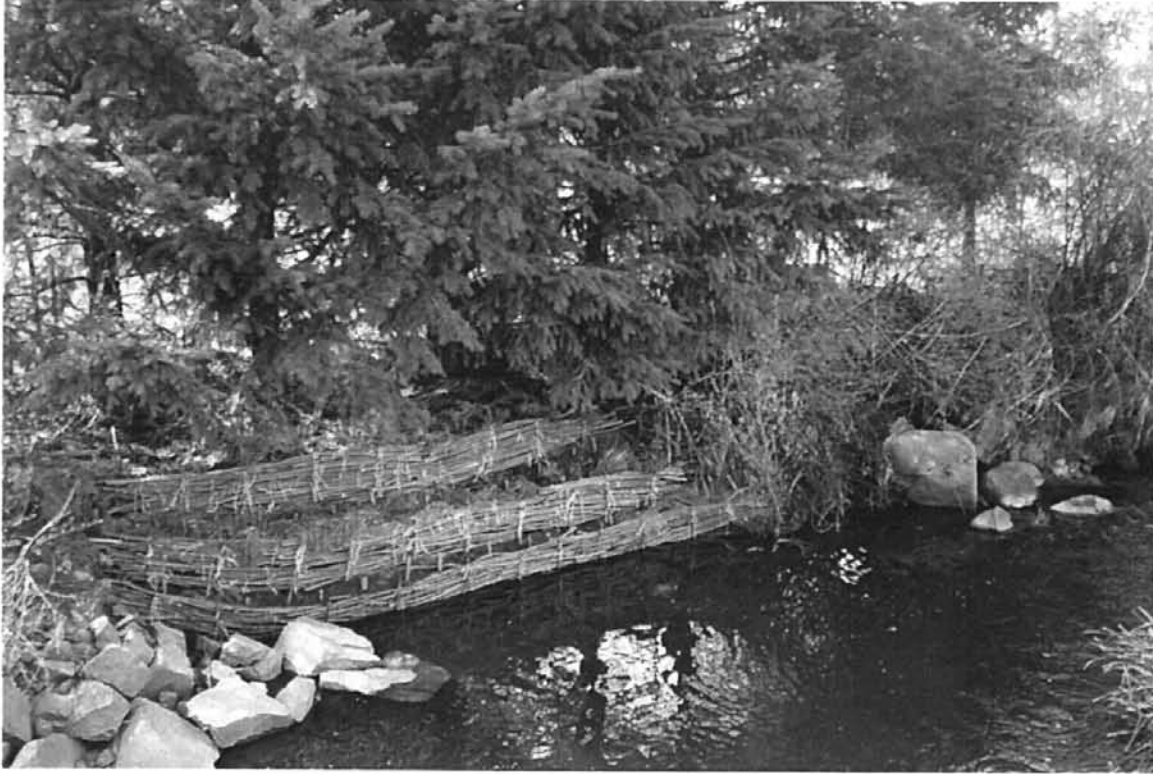
Figure B.1 Willow wattles constructed in Portuguese Creek July 1998.

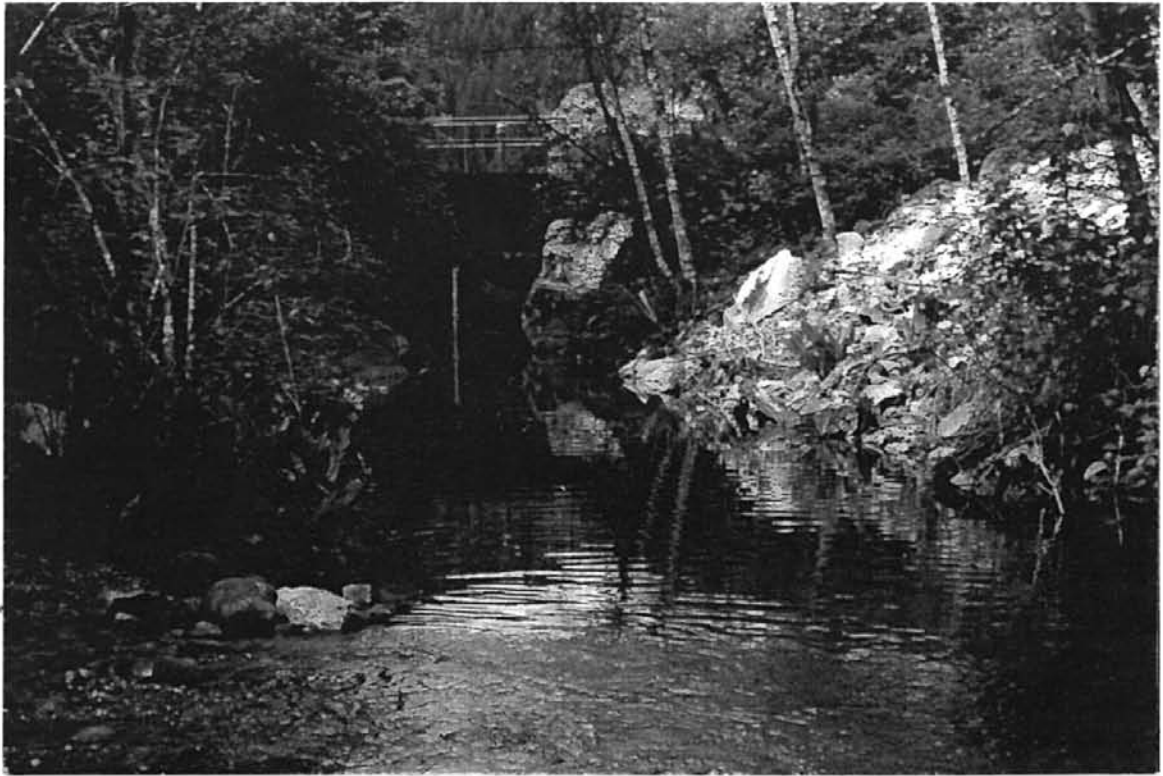
Figure B.1. Headquarters Creek, looking upstream to Wolf Lake Dam (summer 1998).

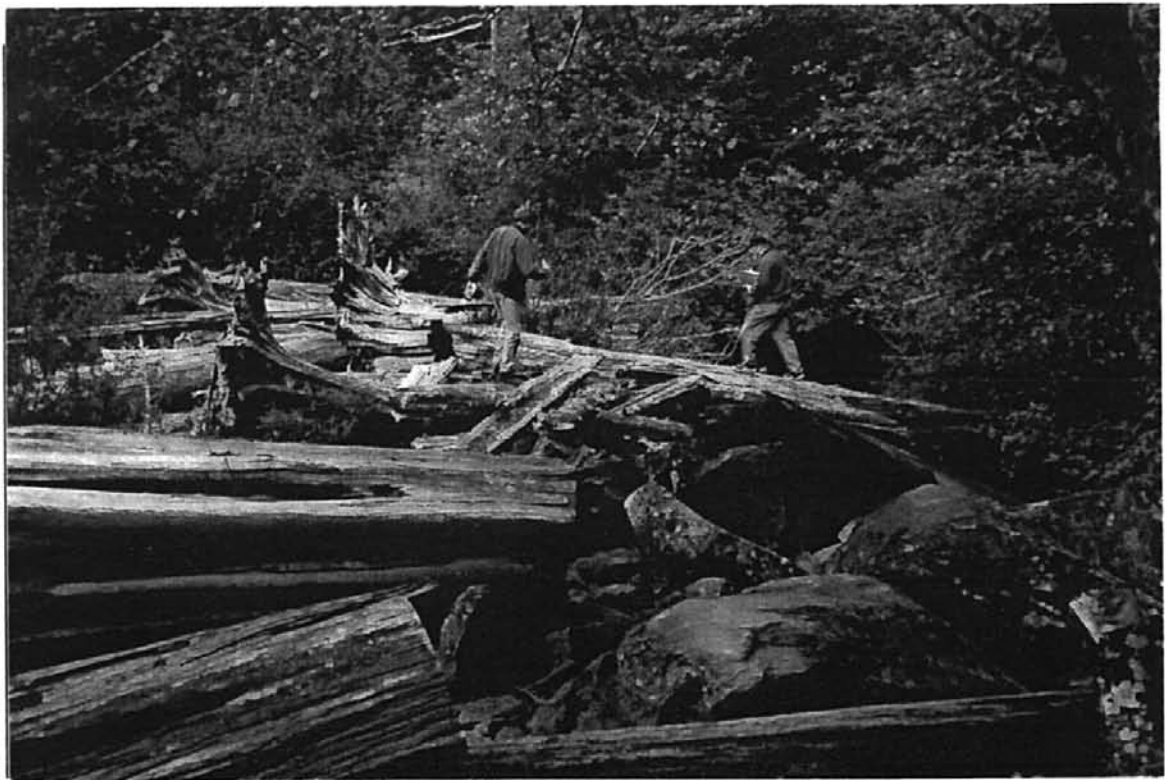
Figure B.2. Weir at Wolf Lake outlet, prior to weir repairs (summer 1998).

The leaking rock weir at the outflow of Wolf Lake was repaired in a cooperative effort between Puntledge Hatchery, DFO engineers, TimberWest and the TRTF during the summer of 1998. Water storage capacity of the lake was increased by 575 acre-feet providing more water for farms and fish during pink salmon migration.

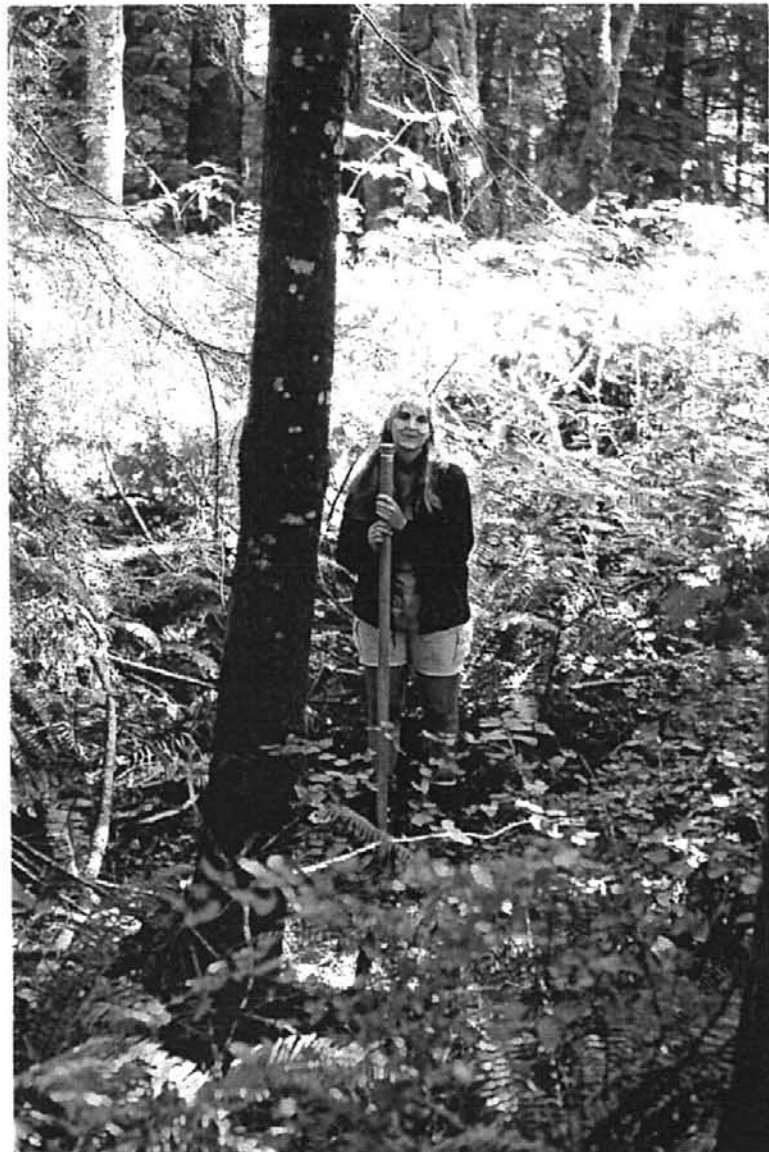
Figure B.4. Index well located by the lower Tsolum River hydrometric station (summer 1998)

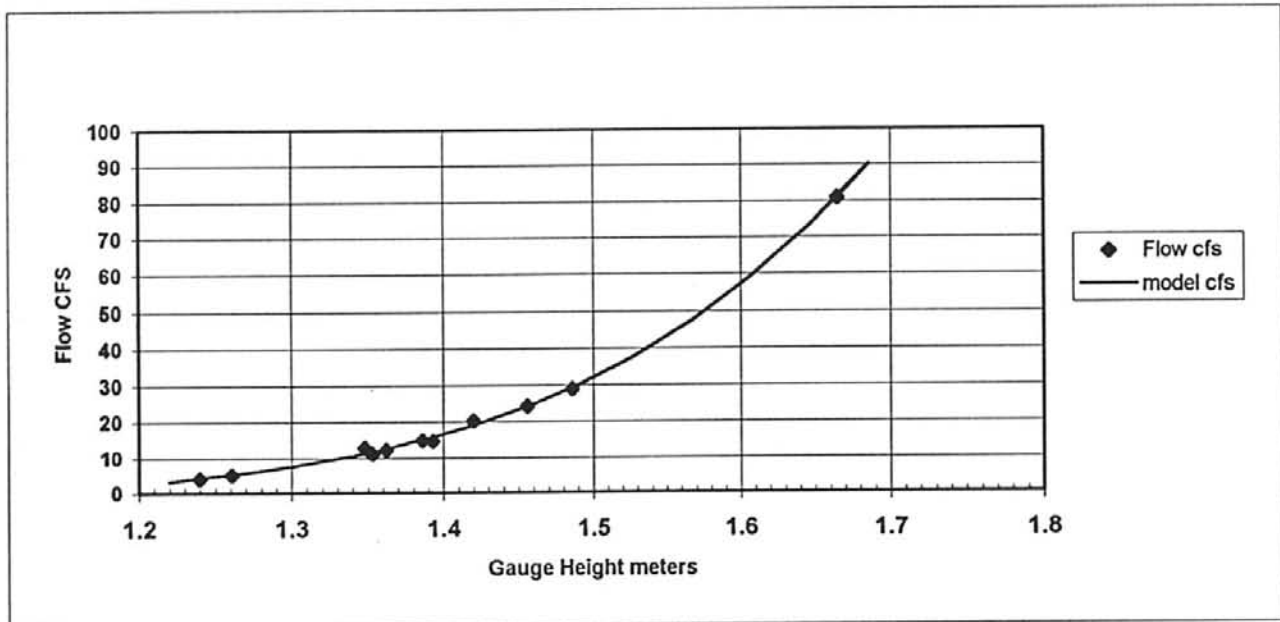
Figure C.3. Headquarters Creek Flow Calibration Curve, October 1998

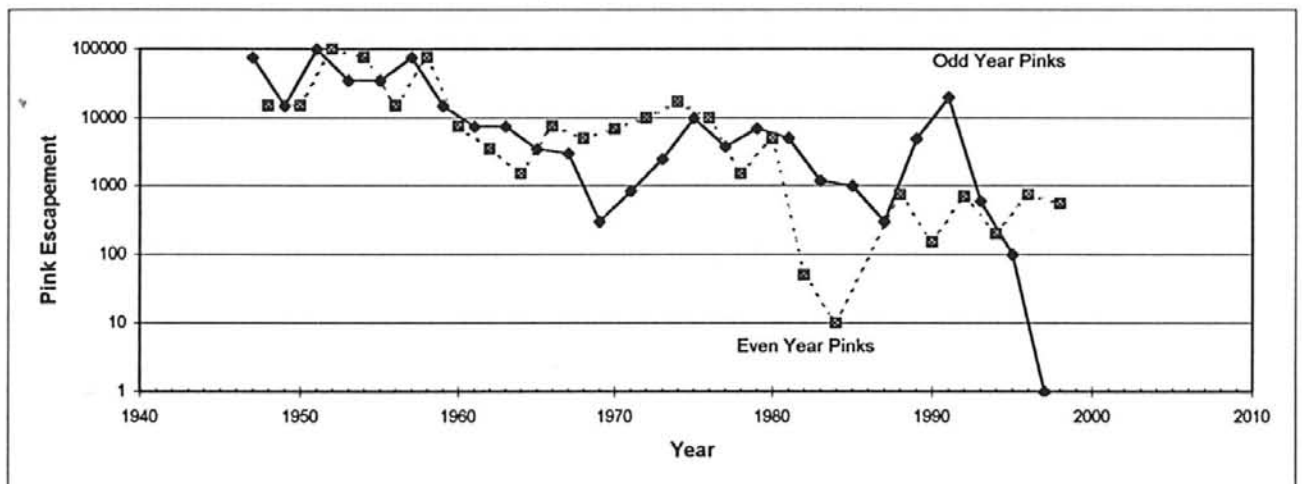
Figure A.2 Semi-log Graph Presentation of Tsolium River Pink Escapement Records. NB. 1 denotes 0 fish observed or escapement unknown.
