Mt Washington Mine Remediation Executive Summary

Tsolum River Partnership

*Project Reference Number
SRK 1CT001.001*

January 2008

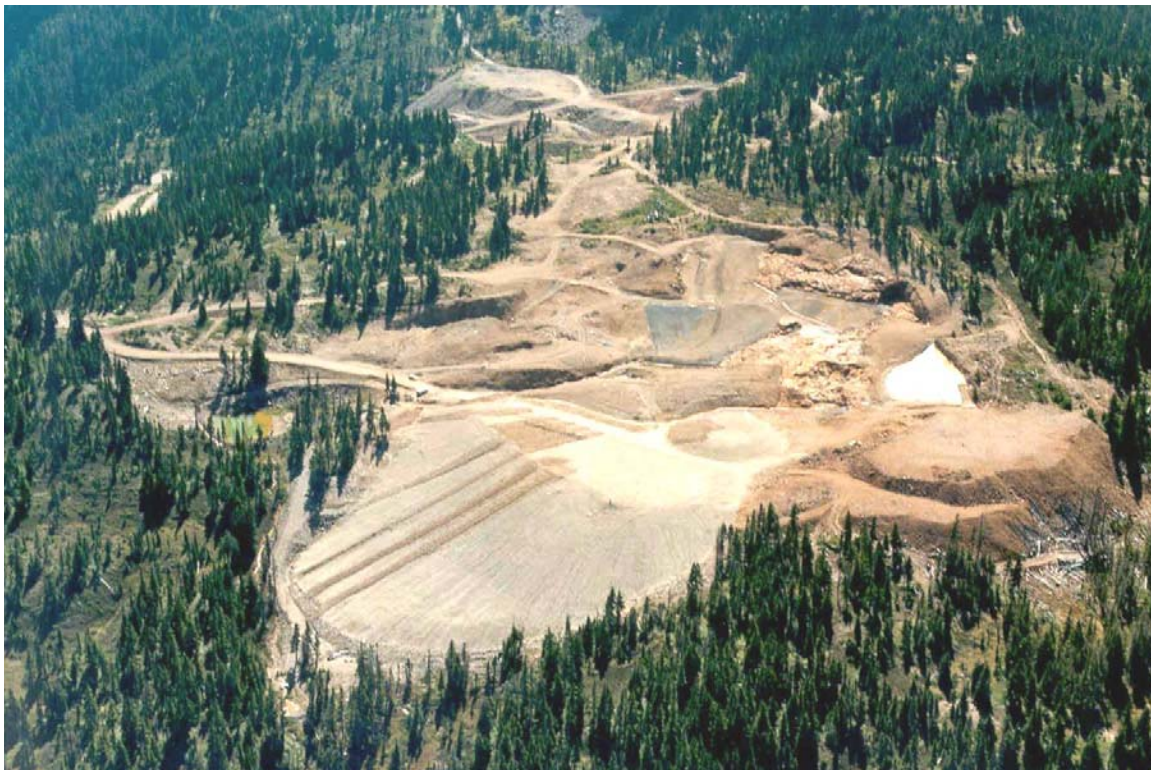
Figure 1: North Pit of the abandoned copper mine below the Mt Washington Ski Field on Vancouver Island

The Tsolum River Partnership retained SRK Consulting (Canada) Inc. (SRK) to develop an Acid Rock Drainage (ARD) remediation plan for the abandoned copper mine on Mt Washington, Vancouver Island. Detailed design features of the reclamation plan were presented in a design report submitted to the Partnership on December 21, 2007. Current plans call for the project to be staged over a period of three years. Subject to the acquisition of project funding, final construction drawings would be prepared in early 2008 in preparation for mobilization to the site by June 2008. A photograph of the site in its current condition is shown in Figure 1.
