CONNOLLY SIDECHANEL

GROUNDWATER LIMITED SALMONID HABITAT SUITABILITY ASSESSMENT

Prepared for Oyster River Enhancement Society (ORES), Department of Fisheries and Oceans (DFO), & Pacific Salmon Foundation (PSF)

November 14, 2014

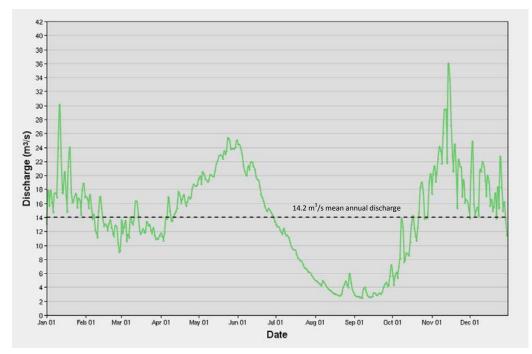
Figure 1. Hydrometric data graph from Canada Water Survey station at Oyster River below Woodhus Creek (08HD011) showing mean daily discharge (m³/s) statistic corresponding to 39 years of data recorded from January 1973 to December 2011 (shown as daily mean over 12 month period).

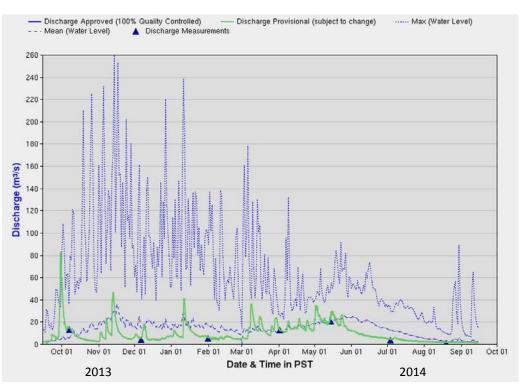
Figure 2. Hydrometric data graph from Canada Water Survey station at Oyster River below Woodhus Creek (08HD011) showing discharge, mean discharge, and maximum instantaneous discharge for the period of Sept. 15, 2013 to Sept. 15, 2014.

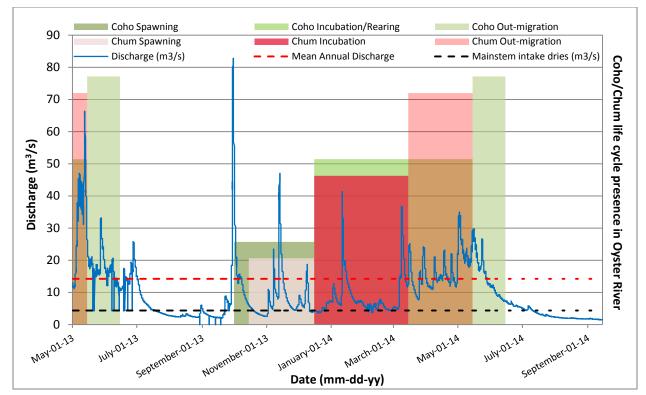
Figure 3. Oyster River hydrometric discharge data (from May 1, 2013 – Sept. 15, 2014) compared against the historical mean annual discharge (14.2 m³/s) and coho/chum life history timing in the system.

According to data from the Water Survey of Canada and a study done by the BC Conservation Foundation (Gaboury & McCullough, 2002), monthly flows in the Oyster River watershed typically begin to rise in October in response to rainfall, peak in November and December, and decline again in June with the lowest discharges occurring in August and September (Figure 1). Historic flow measurements in the Oyster River just below Woodhus Creek measured a mean annual discharge (MAD) of 14.2 m³/s (Silvestri, 2007), an average minimum discharge of 3.49 m³/s in September, and an average maximum discharge of 21.7 m³/s in November (Miles, 2011). The mean annual precipitation for this region is 1434.5 mm per year⁴. Real-time discharge, mean discharge, and maximum instantaneous discharge (all in m³/s) data for the period of Sept 15, 2013 – Sept 15, 2014 (encompassing the study period) is presented in Figure 2. In order to show annual expected presence of salmonids in the Oyster River with respect to the flow regime, available real-time hydrometric discharge data (for the period May 1, 2013 to Sept. 15, 2014) is plotted against the historical MAD (14.2 m³/s) and generalized coho and chum presence in the system during spawning, incubation/rearing, and smolt out-migration life history periods (Figure 3).

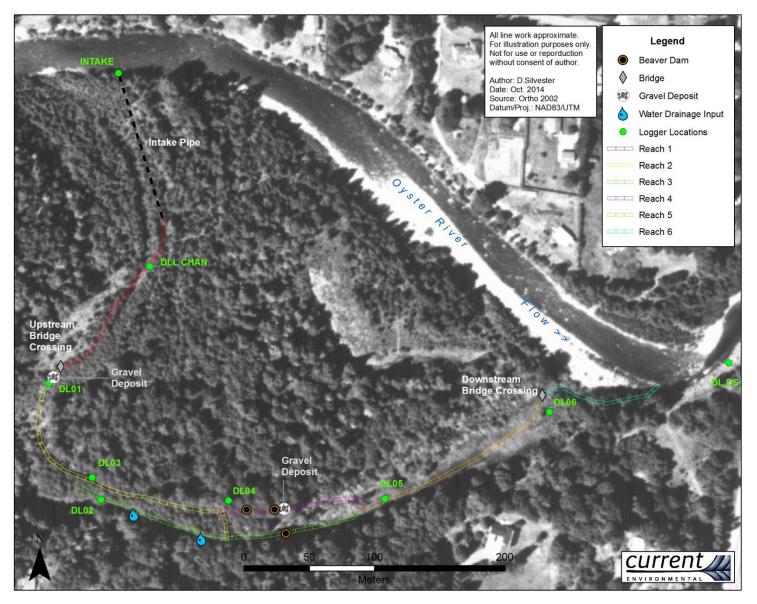
Figure 4. Site map of Connolly Sidechannel showing reaches, reach breaks, and obstructions referred to in the Level 1 Habitat Assessment and the locations of automatic data logger and handmeter sampling locations described in water level and water quality.

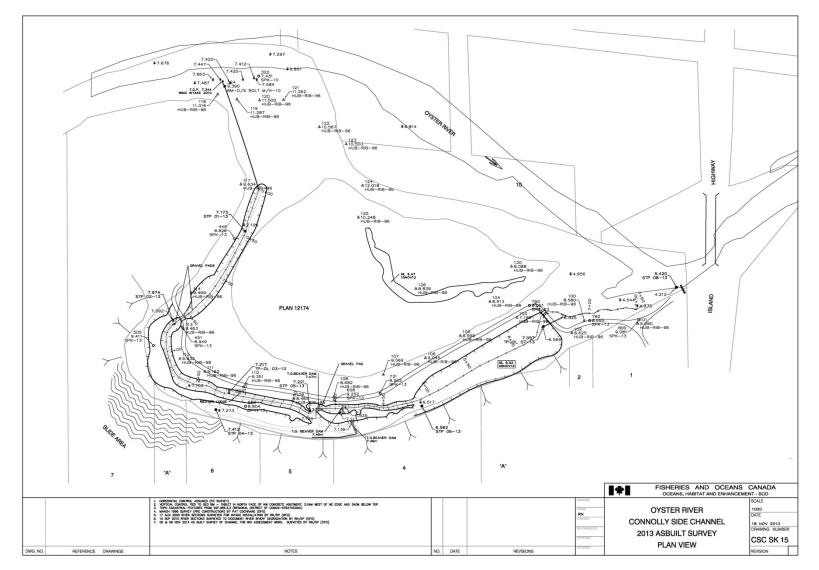
Figure 5. Surveyed site plan of Connolly Sidechannel showing existing condition during the assessment period including elevations of channel features, intake structure and outlet channel, beaver dams, bridge crossings, and spawning gravel locations. (Adapted from DFO; Nov. 18, 2013)

Locations for photographs, reach breaks, habitat unit breaks, obstructions, off-channel habitat, and other points of interest were recorded using a handheld tape and a Garmin GPSmap 60cx with an expected accuracy of ±3 m. Relevant points and linework are shown graphically in maps produced using a desktop GIS platform (Figure 4). A surveyed site plan showing existing condition during the assessment period including elevations of channel features, intake structure and outlet channel, beaver dams, bridge crossings, and spawning gravel locations is adapted from DFO (Figure 5).

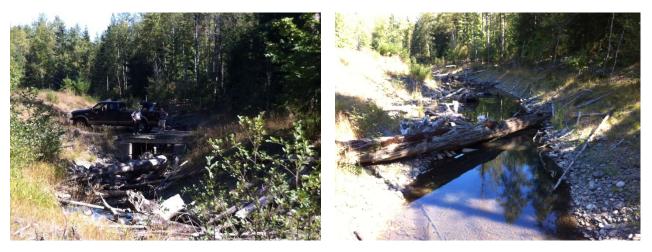
Photo 10. View upstream of the "upstream bridge crossing" that defines the reach break between Reach 1 and Reach 2 (above left). (Sept. 10, 2014)

Photo 11. View upstream of Reach 1 from the upstream bridge crossing showing small patch of gravel (foreground) and general reach character including density of LWD (above right). (Sept. 10, 2014)

During the period of assessment the mainstem intake at 0+000 m was shut off to demonstrate the groundwater only condition of the sidechannel. In general, potential limiting factors to fish production of the reach includes a very high proportion of deep, organic fine substrates and little to no crown or overhanging vegetation, both resulting in *Poor Ratings*. Riparian vegetation is very limited and has been categorized as grass/shrub dominated by Scotch broom on the right bank, and alder pole sapling mixed with broom on the left bank (Photo 10).

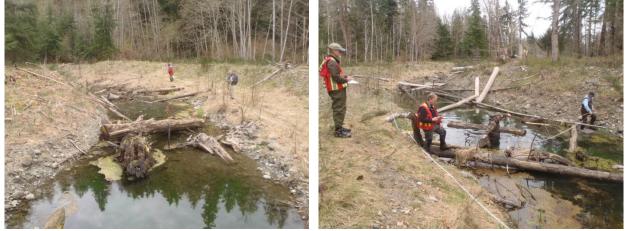
Photo 12. View downstream (above left) of Reach 2 taken from upstream bridge crossing reach break showing typical channel morphology of upstream units. (April 14, 2014)

Photo 13. View upstream (above right) taken from approximate mid channel length of Reach 2 during habitat assessment work showing volunteers ad DFO staff collecting width measurements. (April 14, 2014)

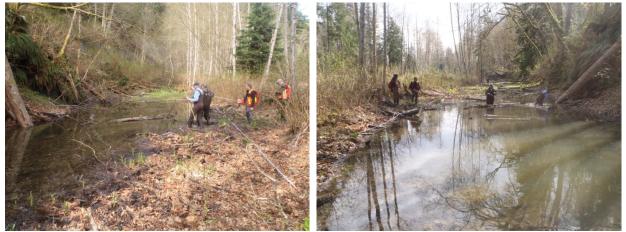
Photo 14. View upstream of Reach 3 (above left) showing alcove marking the upstream end of this reach.

Photo 15. View downstream of Reach 3 (above right) taken from approximate mid length of the reach showing wide and shallow wetted area.

Photo 16. Beaver dam with a 1.3 m crest height above streambed (left) that is a significant water level and flow control feature within the sidechannel located towards downstream end of Reach 3. (April 14, 2014)

The primary limiting factors in this reach are related to high % fine substrates and low % gravel substrates. What isn't captured in the rating of this reach that may have an effect on overall habitat quality is the relatively shallow nature of the reach where during summer months it was observed to dry in many places. The beaver dam located towards the downstream end of Reach 3 is acting as a partial obstruction to up- and downstream salmonid migration and is backwatering a substantial portion of the lower habitat units of Reach 3 (Photo 16). A surface water connection, categorized as a pool under Reach 2 (Photo 17), exists between the relic channel at km 0+380 of the primary channel. The overall rating for Reach 3 is *Fair* (Table 3).

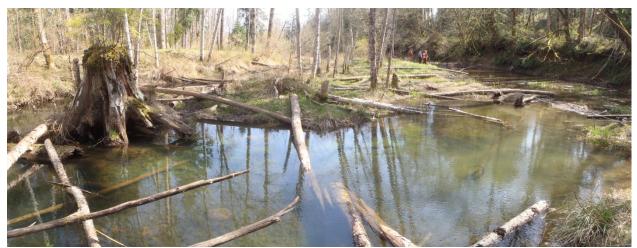
Photo 17. Downstream view of a pool connecting Reach 3 (right of image) with the upstream end of Reach 2 (left of image at large stump) at km 0+380 of the primary channel. (April 4, 2014)

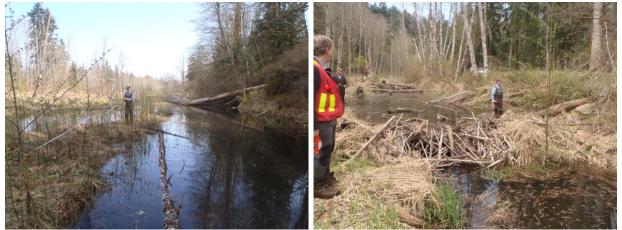
Photo 18. Downstream confluence of Reach 3 (foreground) and Reach 4 (left of image) at km 0+464. (April 4, 2014)

Photo 19. Upstream view of upper end of Reach 4 showing two beaver dams at km 0+400 and 0+420 respectively. (April 4, 2014)

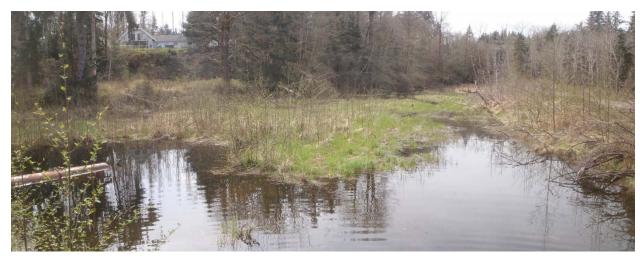
Photo 21. Upstream view of the downstream end of Reach 5 showing the large channel width, instream vegetation, and wetted condition of the channel during habitat assessment effort. Note beaver baffler pipe at left of image. (April 14, 2014)

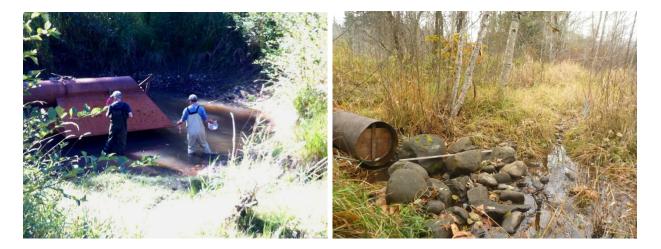
Photo 22. Beaver baffler pipe intake at low water during fish enumeration effort (above left). (Sept. 10, 2014)

Photo 23. View upstream of the upper habitat units of Reach 6 showing beaver baffler pipe plug used to concentrate flows under bridge crossing. (Nov. 6, 2013)

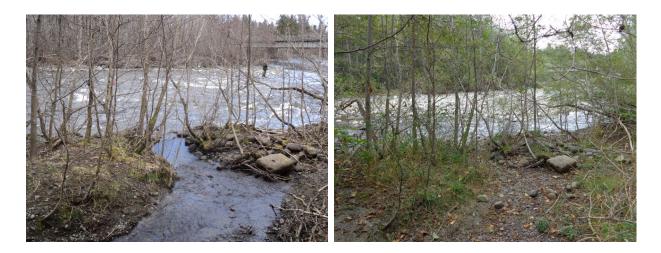
Photo 24. View downstream of mainstem connection at Connolly Sidechannel outlet of Reach 6 and mainstem Oyster River (above left). (Mar. 21, 2014)

Photo 25. View downstream of mainstem connection at Connolly Sidechannel outlet of Reach 6 and mainstem Oyster River (above right). (Sept. 17, 2014)

Reach 6 begins at the outlet of Reach 5 at the downstream bridge crossing at chainage km 0+634 (Photo 20) and flows downstream until the confluence with the Oyster River mainstem at km 0+725 (Photo 24). Reach 6 is seasonally backwatered by the Oyster River during periods of high winter flows; at the time of assessment there were flows from Reach 6 entering the mainstem over an approximate 1 m drop over cobble substrates. Reach 6 was observed to have dried completely during the period of summer drought from June-Sept (Photo 25).

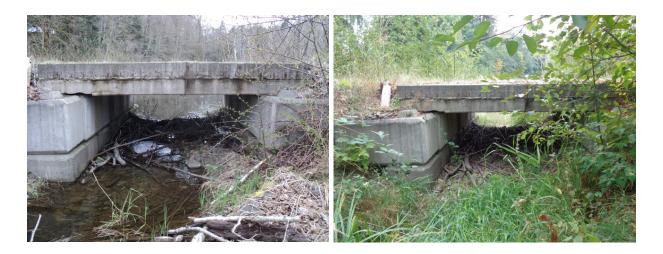
Photo 26. View upstream of downstream bridge crossing (above left) that defines the reach break between Reaches 5 & 6 taken from upstream end of Reach 6 showing flow connectivity and beaver dam acting as partial barrier to fish passage. (Apr. 11, 2014)

Photo 27. View upstream of downstream bridge crossing (above right) taken from upstream end of Reach 6 showing dry seasonal conditions and vegetative growth (Sept. 17, 2014)

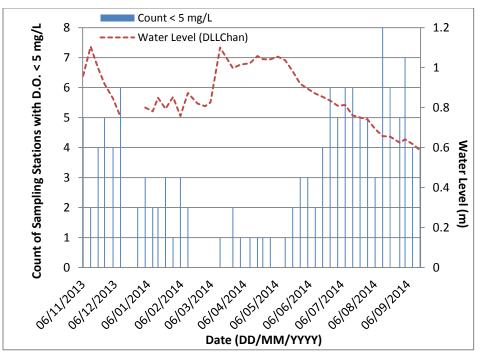
Figure 6. Count (i.e. number of observed occurrences) of sampling stations in Connolly Sidechannel (eight total) with dissolved oxygen (mg/L) concentrations less than the 5 mg/L instantaneous critical limit for salmonids per weekly handmeter sampling effort from Nov 6. 2013 to Sept. 17 2014.

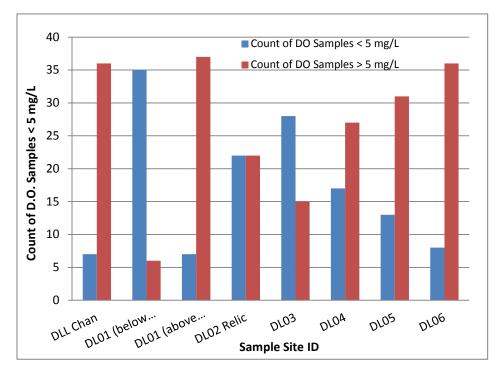
Figure 7. Bar graph showing the count (i.e. number of observed occurrences) of weekly handmeter dissolved oxygen measurements greater and less than the 5 mg/L instantaneous critical limit for salmonids, organized by sampling station from Nov 6. 2013 to Sept. 17 2014.

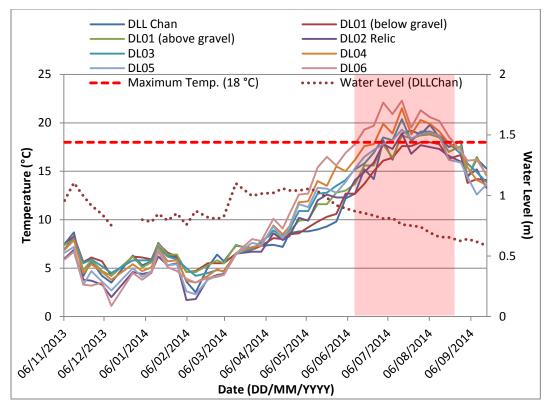
Figure 8. Temperature (°C) measured weekly by handmeter at seven sites throughout the Connolly Sidechannel from Nov 6. 2013 to Sept. 17 2014 with comparison to water levels measured at DLL Chan.

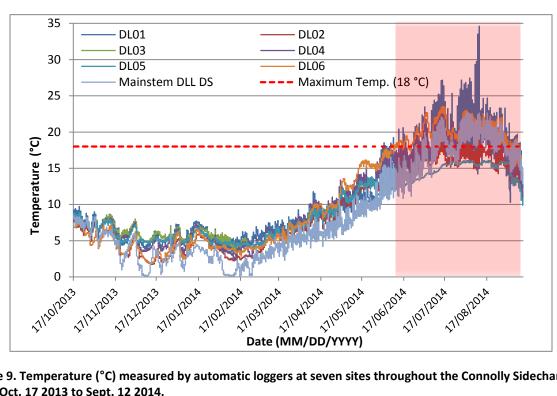
Figure 9. Temperature (°C) measured by automatic loggers at seven sites throughout the Connolly Sidechannel from Oct. 17 2013 to Sept. 12 2014.

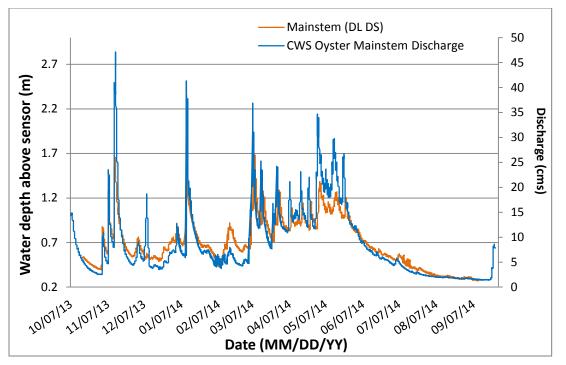
Figure 10. Comparison of Oyster River mainstem discharge (cms) data from CWS Station (08HD011) versus mainstem datalogger installed 60 m downstream of confluence with Connolly SC outlet ("DL DS") from Oct. 7, 2103 – Sept. 12, 2014.

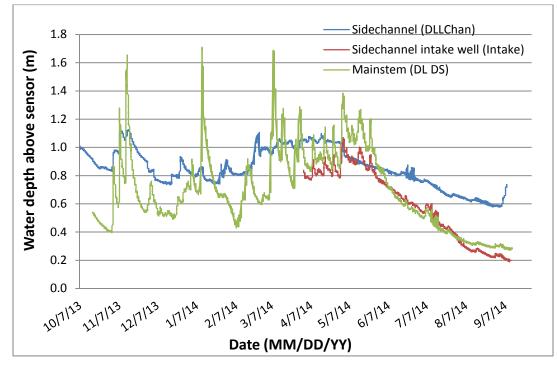
Figure 11. River levels measured as depth of water above logger (m) collected from three locations (1) Oyster River mainstem 60 m downstream of confluence with Connolly SC outlet (green line), (2) Intake to SC in manhole at Oyster River mainstem (red), (3) in Connolly SC near intake outlet during period from Oct. 7 2013 – Sept. 27 2014.

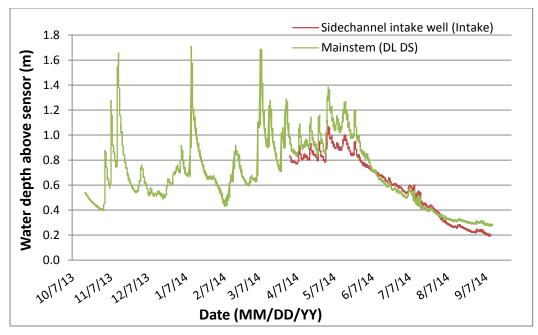
Figure 12. River levels measured as depth of water above logger (m) showing comparison between two mainstem locations (1) Oyster River mainstem 60 m downstream of confluence with Connolly SC outlet (green line), (2) Intake to SC in manhole at Oyster River mainstem (red) during period from Oct. 7 2013 – Sept. 27 2014.

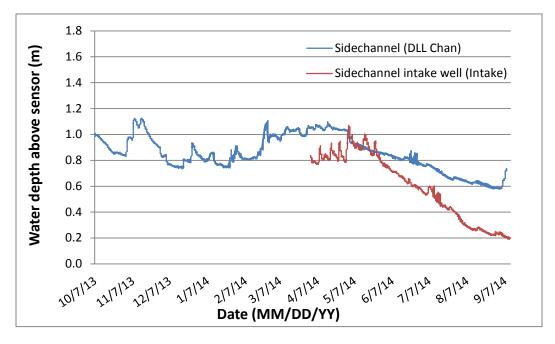
Figure 13. River levels measured as depth of water above logger (m) showing comparison between mainstem vs groundwater condition of the Connolly SC at locations inside manhole intake well (red) and in Connolly SC near intake outlet (blue) during period from during Oct. 7 2013 – Sept. 27 2014.

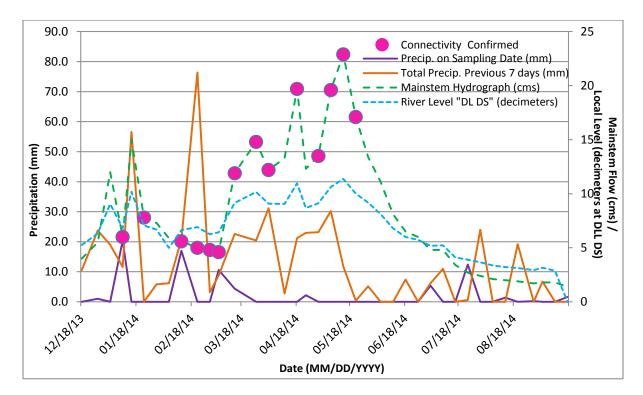
Figure 14. Comparison of visually confirmed mainstem/sidechannel connectivity plotted against precipitation (mm) (on sampling day and as a total of previous 7 days), mainstem hydrograph measurements (cms), and mainstem data logger levels (dm) for the period of Dec. 18 2013 – Sept. 17, 2014.

Visual monitoring of mainstem Oyster River water levels relative to the Sidechannel outlet was done on a weekly basis throughout the sampling period in conjunction with handmeter water quality measurements and photopost monitoring. Roughly weekly outlet flow observations and photos were taken at the confluence between Reach 6 and the Oyster River mainstem (Photo 24 & Photo 25) and at the downstream bridge crossing (reach break between Reach 5 & 6; Photo 26 & Photo 27). Connectivity was visually assessed based on whether it appeared the Sidechannel outflow was wetted sufficiently to support fry passage. A comparison between visually confirmed mainstem/sidechannel connectivity¹² plotted against precipitation (on sampling day and as a total of previous 7 days)¹³, and mainstem hydrograph measurements¹⁴ is provided in Figure 14.
